# OPERATION PLUMBBOB

Project 30.7

TEST OF GERMAN UNDERGROUND  
PERSONNEL SHELTERS

Issuance Date: June 25, 1962

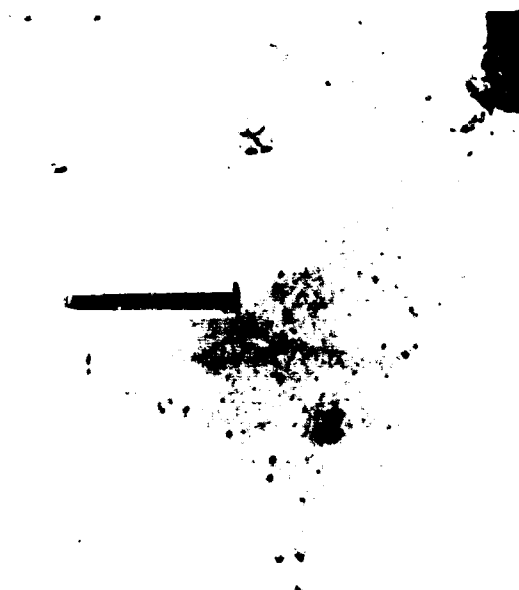
Fig. 3.40—Detail of end of chipped-out section facing toward the main entrance (structure RAc).

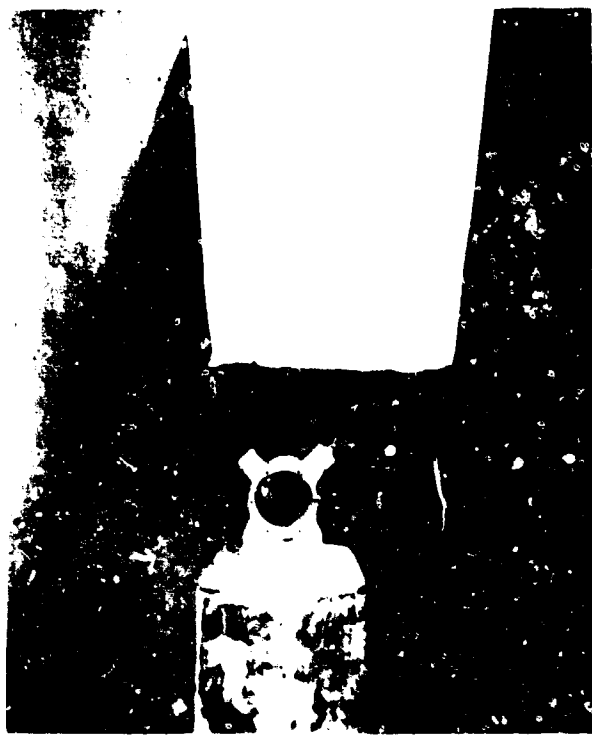
Fig. 3.49—Looking up entrance toward GZ, after cleaning (structure RAc).
